NAUGATUCK RIVER BASIN
WINCHESTER, CONNECTICUT

PARK POND
DAM - CT 00632
DIKE - CT 01708

PHASE I INSPECTION REPORT
NATIONAL DAM INSPECTION PROGRAM

MARCH 1981

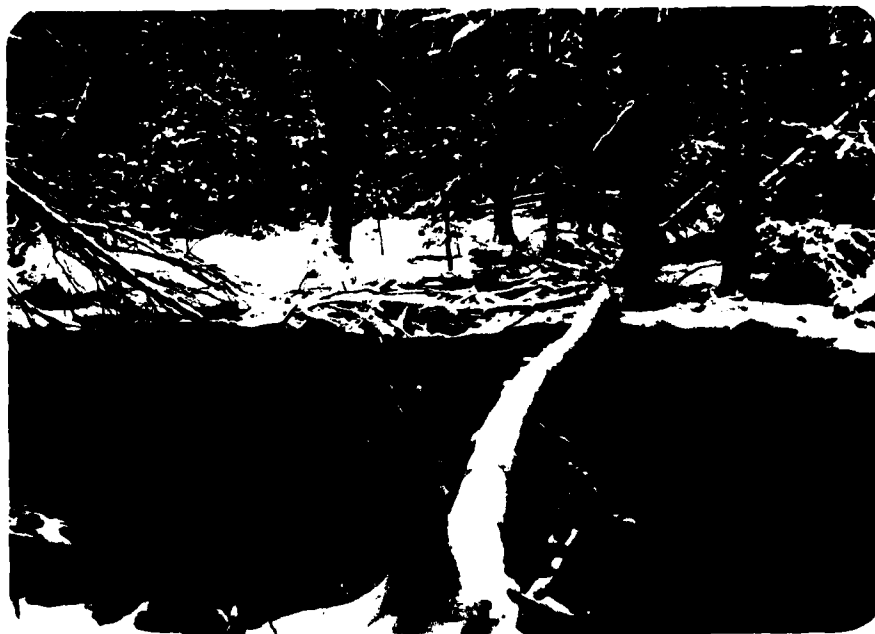
PHOTO NO. 16*

is so deteriorated as to be almost unrecognizable, Photo 16, page C-9 in Appendix C. The diversion capacity of the structure is minimal in its present condition. Even with complete failure of the structure, the diversion channel would continue to divert 0.02 square miles of watershed to the pond.

DIVERSION STRUCTURE AT FAR END OF FALLEN TREE.
EXTENSIVELY ERODED WITH MANY BREACHES.
